Fishing 2003 Safety Digest

This *Safety Digest* draws the attention of the marine community to some of the lessons arising from investigations into recent accidents. It contains facts which have been determined up to the time of issue.

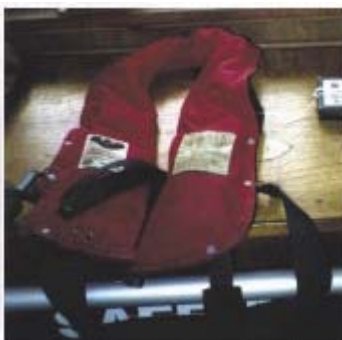
Nobody saw him go over the side, but the circumstances suggest he was standing in the starboard pound to connect the towing wire to the net. A feature of the pound is its proximity to the stern roller, which rotates as the nets are paid out. It is impossible to say what happened, but the possibility exists that he was somehow taken overboard by the rotating roller.

The crewman had been wearing ordinary clothing: a hard hat and the inflatable lifejacket. Only the lifejacket was found and recovered. Once again, it is impossible to reconstruct exactly what happened, but a properly secured lifejacket should not have become detached. The evidence suggests it was not being worn correctly, and it is likely the victim slipped the lifejacket over his head without passing the harness around his waist. When he entered the water the lifejacket slipped off. The particularly sad feature was the relative ease with which the lifejacket was subsequently seen, but nothing was found of the man.

1. The aft boundary of the two sternpounds is the stern roller. Because this is able to rotate freely it cannot serve the same purpose as a guardrail or bulwark. Without a barrier between the pound and the roller, crew can easily come into contact with the roller. If it is turning, it might then drag them overboard. Stern rollers should be viewed in the same way as any rotating machinery. They are dangerous and must be guarded if personnel are likely to be very close by.

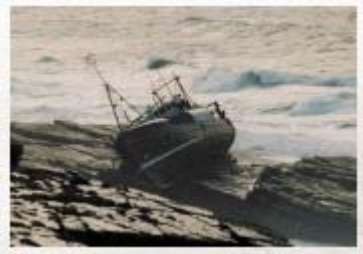
Her skipper, who had not slept for about 23 hours and had recently held a mobile telephone conversation with a friend, attempted to alter course while in the Sound. Using the joystick control, he failed to use the correct procedure for changing from automatic to manual steering, and did not realise the vessel was not turning as intended until immediately before the vessel grounded. By the time he did realise there was a problem it was too late for him to do anything about it. When the tide fell, the fishing vessel was embarrassingly high and dry. She was refloated the following day. There was no pollution, and damage to the vessel was minor.

1. Everybody makes mistakes, but we are more likely to do so when we've not had enough sleep. Tiredness makes it difficult to concentrate, and our ability to remain alert to what is happening around us is much reduced. Simple errors occur that would be unthinkable in normal circumstances. Drowsiness is the obvious symptom of fatigue. Other indicators which affect concentration, awareness and alertness are harder to identify, but are just as dangerous. Don't assume that just because a competent watchkeeper is awake that he can do the job. You only have to think what it is like to do a simple task at home at the end of a long day to know how difficult it can be. It is no different at sea even if you think you can do it. People who go without sleep for more than about 18 hours are less able to perform routine tasks than had they exceeded the drink drive limit.

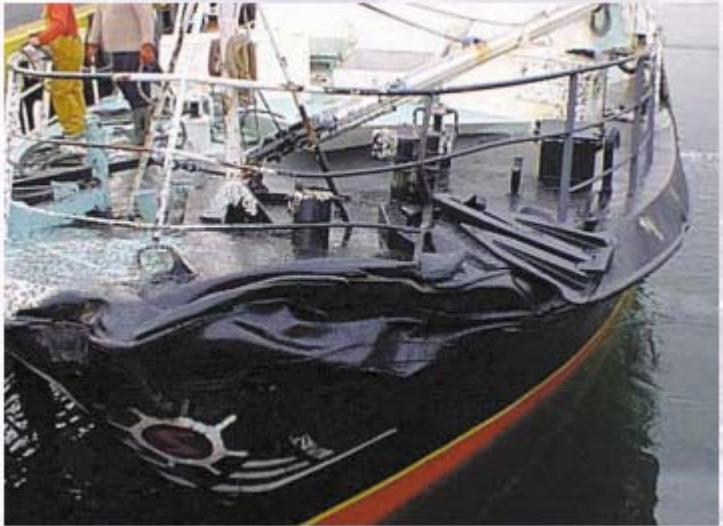
At about the same time, the deckhand aboard the fishing vessel attempted to avoid a collision by turning to starboard but, as automatic steering was selected, there was no response.

The fishing vessel collided with the ship's port bow at about 0429 causing a 6m gash in the No 1 (port) tank, followed by lesser impacts amidships and in the vicinity of the accommodation. About 110 tonnes of oil leaked from the ruptured tank into the sea, before the contents of the tank were transferred.

A feature of this incident is how late each watchkeeper detected the other vessel. Once again it reminds people how important it is to keep a very good lookout, especially at night.
