FISHING ACCIDENT FLYER

COLLISION AND SINKING IN FOG WHILE PAIR TRAWLING

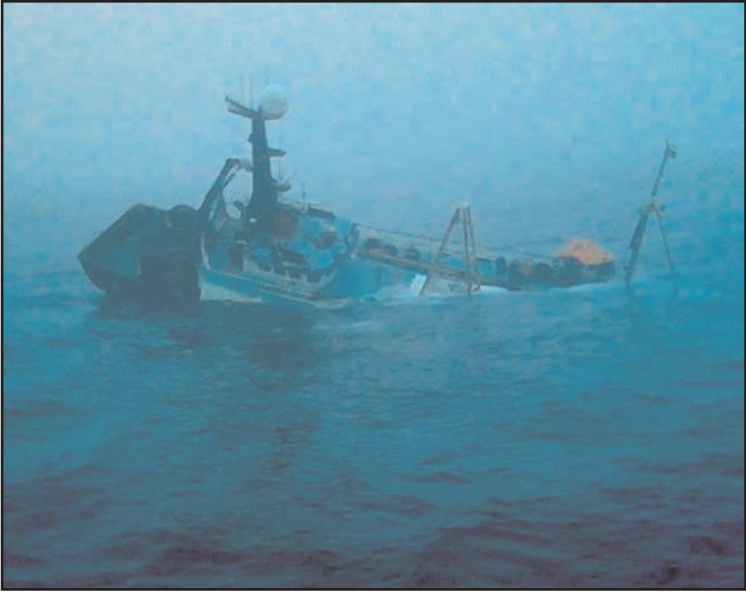
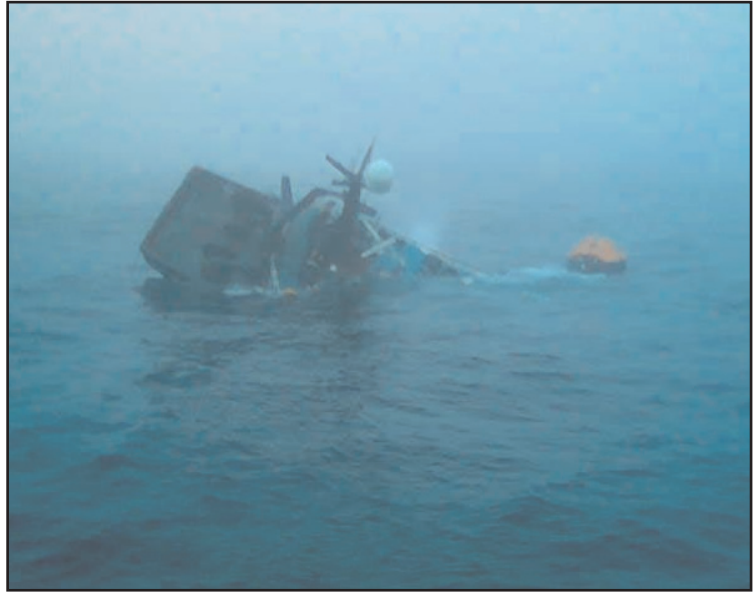
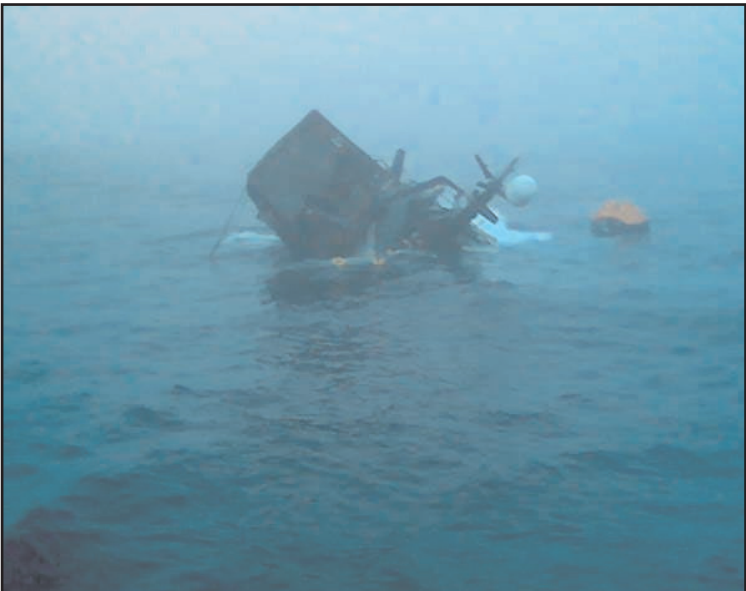
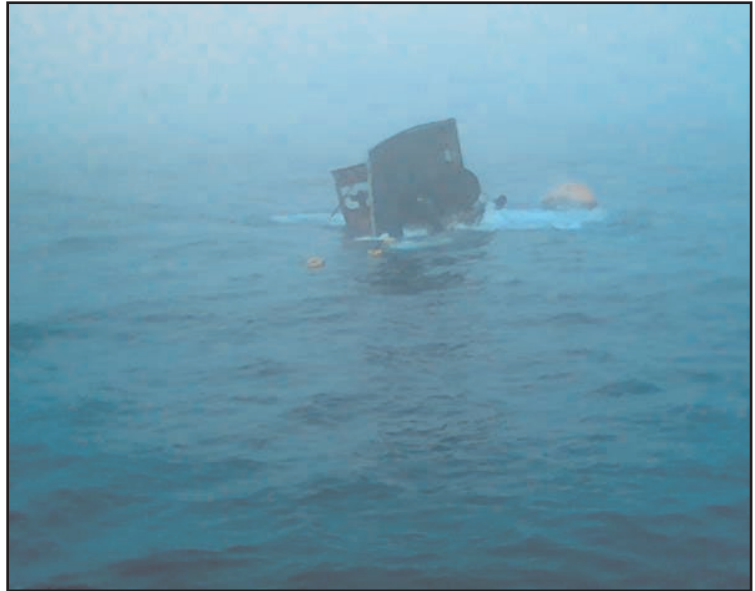
The collision caused a split in the *Harvester's* side in the fish hold, and also split the bulkhead between the fish hold and engine room. All the available pumps were started, and although they were keeping pace with the water level in the engine room, they could not cope with the water entering the fish hold. The skipper decided to abandon his vessel, and the liferafts were launched. The crew put on their immersion suits, and some also put on their lifejackets. All 5 crew were picked up from the liferaft by *Ocean Harvest*, and were landed ashore later that day.

Shows *Harvester* sinking over a four minute period
