MARINE ACCIDENT INVESTIGATION BRANCH

FISHING ACCIDENT FLYER

Engine room fire started by shrimp boiler

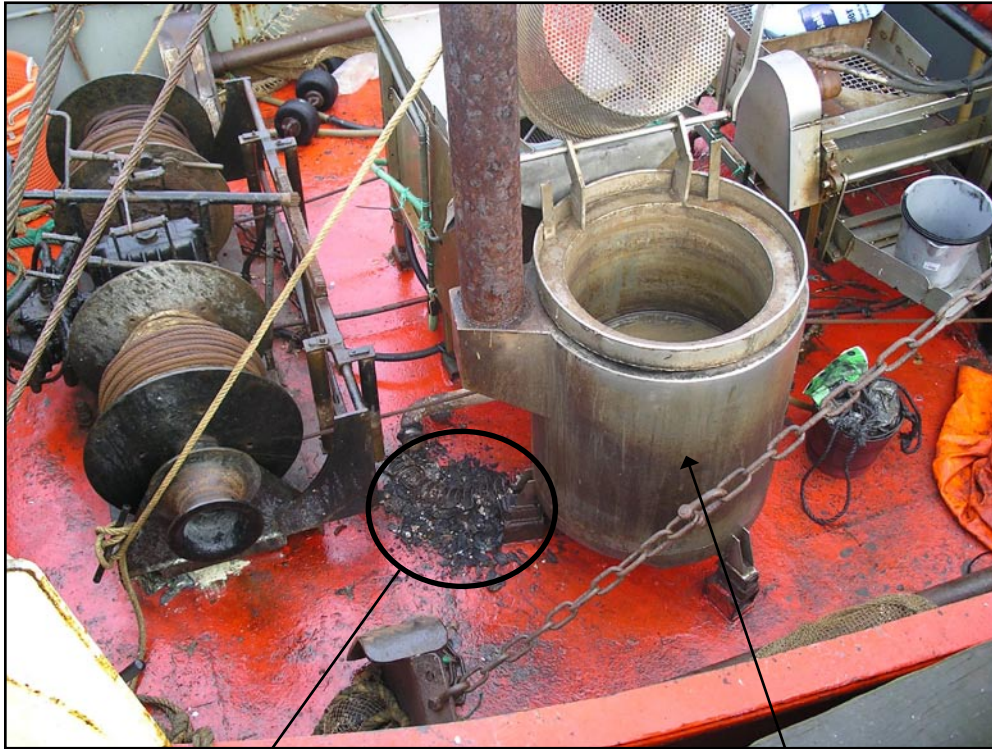
Burnt section of plastic air supply trunking

Shrimp boiler

Whenever the boiler was lit or shut down, it was possible for unburned fuel to enter the air supply line, if the blower was switched off before the fuel was burnt off. Diesel oil was therefore able to accumulate in the air supply trunking, particularly in the corrugations of the plastic connecting pipe. The investigation determined that the boiler flame was drawn into the engine room, through ignition of the oil in the boiler air supply trunking after the boiler air blower was switched off. The air flow reversal was due to the partial vacuum created by the main engine in the engine room because the ventilation system was completely blocked by rust flakes. This resulted in a plastic section of the blower air trunking on the main deck and seating material, and a plastic oil drum in the engine room, catching fire.
