MARINE ACCIDENT INVESTIGATION BRANCH

## FISHING ACCIDENT FLYER

### Fatigue - take it seriously!

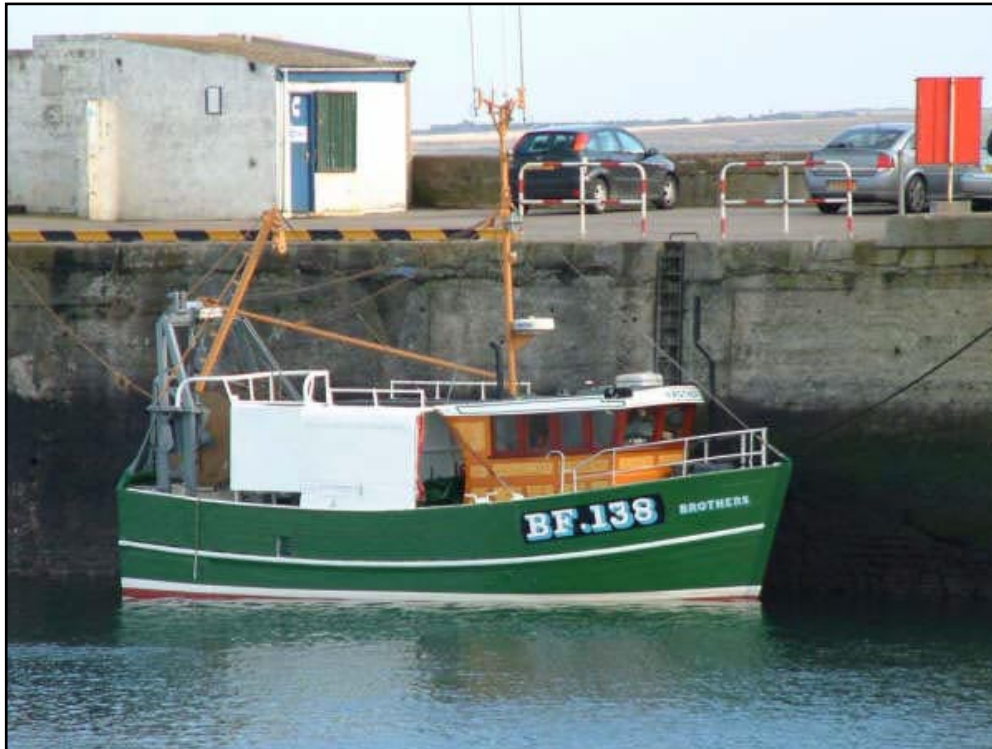
The Banff registered stern trawler *Brothers* BF138 sailed from Gairloch with a skipper and one crew at about 0225 on the morning of 1 June 2006 intending to fish for prawns in the Trodday fishing grounds. At about 0520 the vessel grounded and then sank off Eilean Trodday, a small uninhabited island off the north coast of Skye. No "Mayday" message had been broadcast.

The evidence indicates that the vessel probably grounded due to one of the crew falling asleep in the wheelhouse, which allowed the vessel to continue on autopilot past her intended fishing grounds and onto the rocky shore. Both crew would have been suffering the effects of fatigue brought on by a number of long days at work, with only short, broken sleep periods. Both crew had also drunk some alcohol before the vessel left the harbour.
