MARINE ACCIDENT INVESTIGATION BRANCH

FLYER TO THE FISHING INDUSTRY

MAGGIE ANN:

FATALITY DUE TO MANOVERBOARD

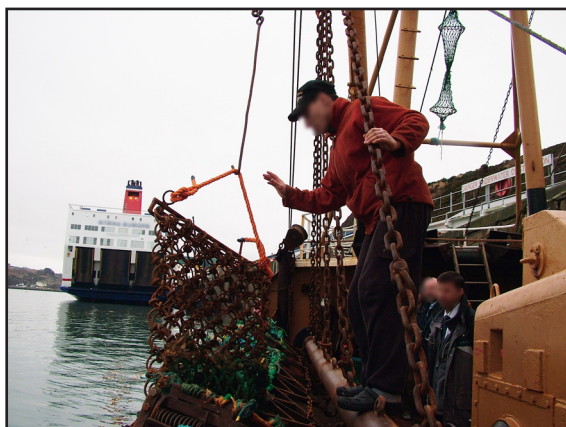
Figure 1

The deckhand was not wearing a personal flotation device or a safety harness when he stepped onto the elevated dredge beam, and it was not the practice for deckhands to do so. On this occasion, he let go of the suspension chain (**Figure 1**) to facilitate his emptying one of the dredge bags. As he grasped the dredge bag with both hands, the lifting becket parted, causing him to fall forward and with no protection from the bulwark, to continue to fall overboard.

The bulwark height had previously been increased to allow the scallop dredges to be taken on board in a more controlled manner. However, this meant that when the dredge bags were full, the dredge beam could not be readily lowered into a secure position before the dredge bags were emptied.

1. The lifting becket parted at a point of attachment to the dredge bag which was prone to wear. A robust inspection and maintenance regime for the working gear might have identified the wear and have prevented the failure. Ensure you have a regime that does so.

3. The fitting of a 'tipping bar', commonly used on scallop dredgers, would have enabled all the dredge bags to be inverted at the same time and have avoided the need for deckhands to step onto the dredge beam or to lean over the gunwale. The best way to control a risk is to remove the hazard altogether.
