## FLYER TO THE FISHING INDUSTRY

### Capsize of fishing vessel *Aquila* with three fatalities

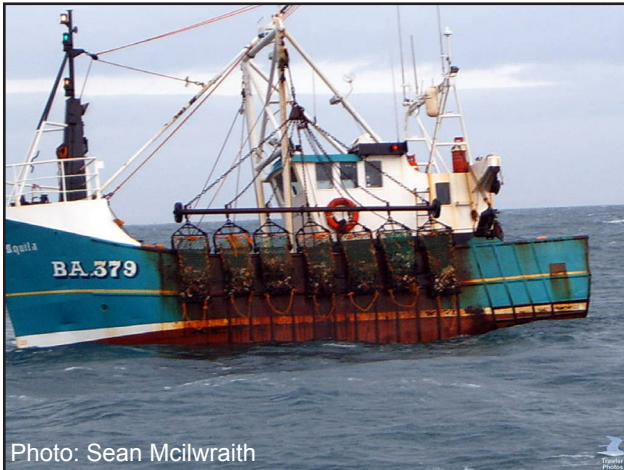
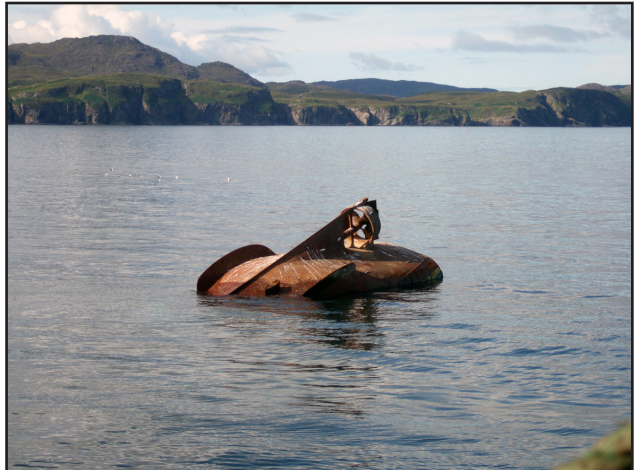
On 20 July 2009, at about 1540 UTC, the starboard warp of the scallop dredger *Aquila* became snagged on the seabed while she was trawling, downwind, in moderate to heavy seas near the isle of Eigg.

The vessel almost immediately veered and heeled over to starboard. The skipper was heard to pull the engine control back to neutral, but a succession of large waves then struck the vessel and she rapidly capsized. The three crewmen were initially trapped, and as water entered the mess room through the open accommodation door one of them dived down and out through the door to escape from the vessel.

After the accident the vessel was salvaged and an analysis of her stability was undertaken. This found that additional ballast had been fitted to the vessel and, with the carriage of more fishing gear, her displacement tonnage was found to have increased by 32%.

The ballast had been placed under the accommodation floor and also below the steering flat, to increase the stern trim and thus the depth and thrust of the propeller. However, the resultant centre of gravity of the additional ballast was found to be 1.5m above the keel which meant that the vessel no longer met the stability requirements for larger fishing vessels.

1. When planning to add ballast or making other modifications to a vessel, the effect of such action on a vessel's stability should be properly assessed by a competent person.
2. The risks of fishing gear becoming snagged, particularly when trawling downwind, should be fully assessed to ensure appropriate control measures are in place to prevent water ingress or capsize.
