MARINE ACCIDENT INVESTIGATION BRANCH

FLYER TO THE FISHING INDUSTRY

KERLOCH:

GROUNDING AND FOUNDERING

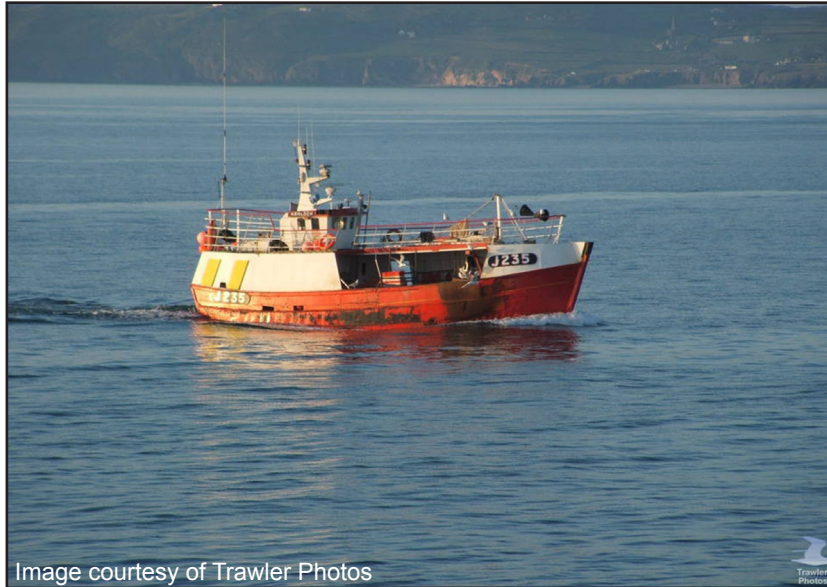
Kerloch

The Jersey-registered 15.45m crabber *Kerloch* (J235) was returning to port late on the afternoon of 20 February 2010, when she ran aground on Crow Rock, off the Pembrokeshire coast.
