This case will highlight where a misapplication of the ColRegs led to a collision and the sinking of a fishing vessel.

Collision between a Supply Vessel and a Fishing Vessel whilst "Pair Trawling" in the N. Sea.

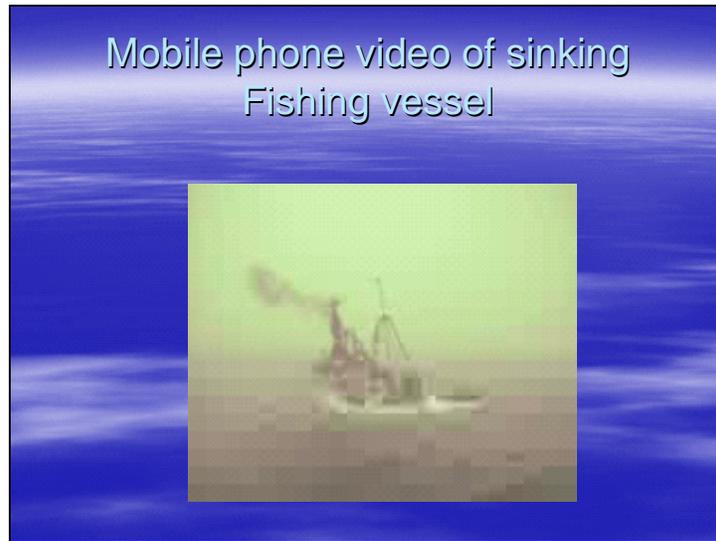
30 seconds after the VHF call, you strike the easterly fishing vessel on the starboard side under her 'A' frame.

The impact rolls the fishing vessel heavily to port, throwing those sleeping on the starboard side of the cabin out of bed.

The crew of the fishing vessel check the engine room and fish hold and discover water entering both spaces from splits in the hull at the forward end of the engine room and after end of the fish hold. The impact has also split the starboard fuel tank.

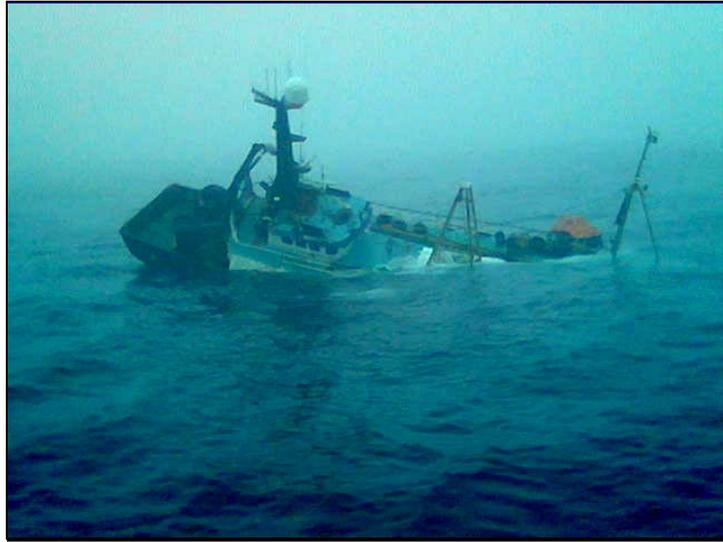
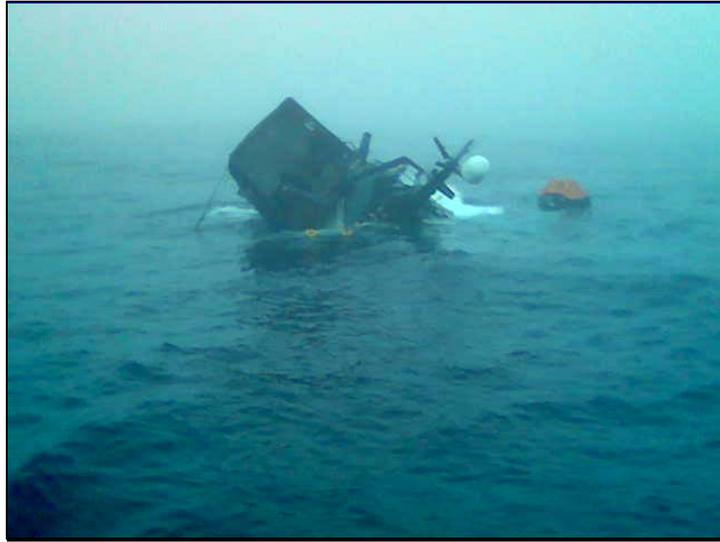
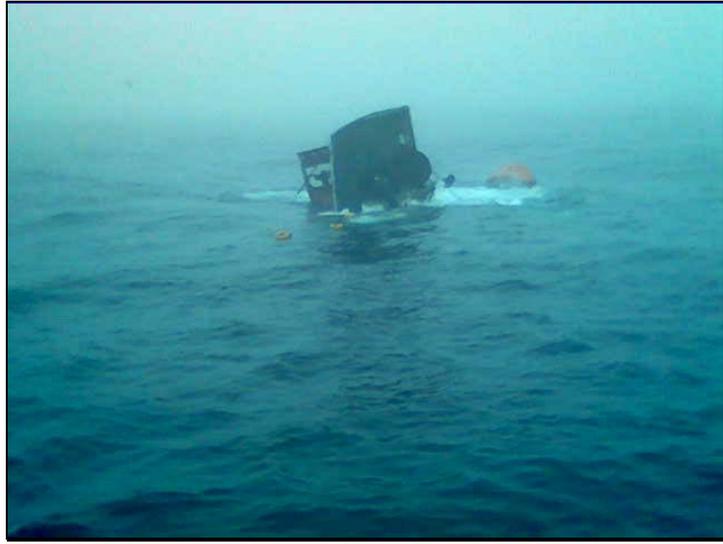
The video and photographs show what happened next
