Recurring themes in MAIB accident investigations

**Capsize of a Beam trawler in the English Channel.**

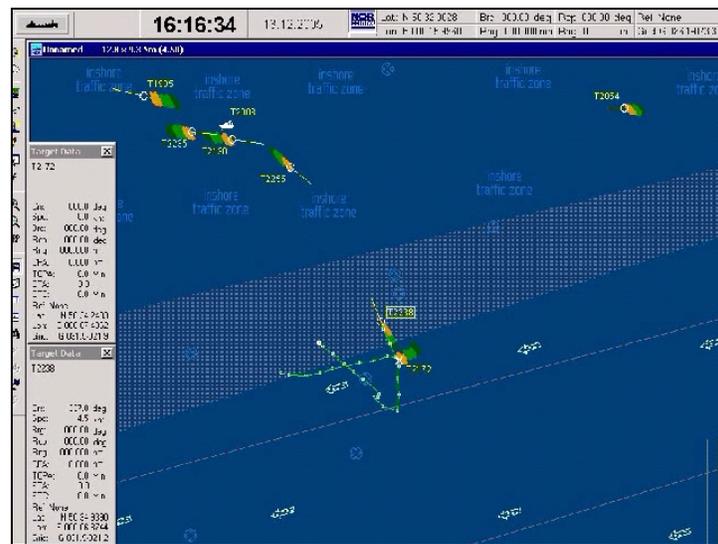
CNIS playback of accident.

Your vessel is labelled 2238 (target surrounded by a box).

Watch for the target disappearing as the vessel capsizes and the transponder is immersed.
