FISHING ACCIDENT REPORT

CREW FALL INTO FISH HOLD

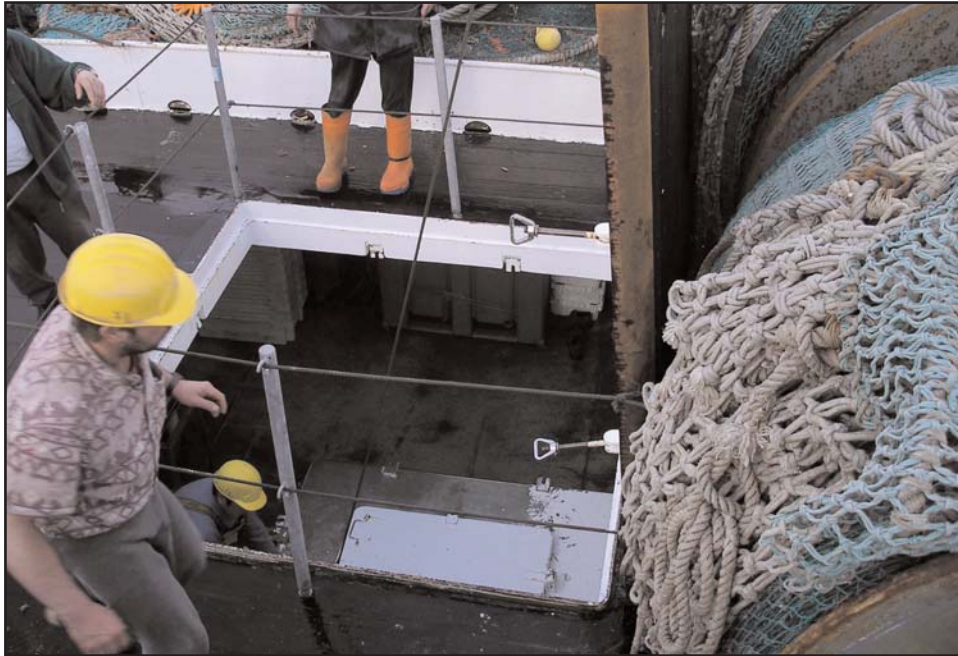
Using jury-rigged lifting gear on board a 35m trawler, two deckhands were being lifted out of the fish hold when they slipped and fell back down a distance of more than 4m. Both of the deckhands were taken to hospital with serious injuries.

The trawler had just finished landing her catch when the accident happened. Although the vessel had a hydraulic crane, with which to land the catch, the crew thought it was too slow. To speed up landing operations, the crew made up their own rigging, arrangement for lowering and lifting the catch in and out of the hold.

The obvious cause of this accident was the misuse of the lifting gear. Dangerous misuse of various equipment on fishing vessels is not uncommon and in many cases can be attributed to a macho image some fishermen wish to portray. Skippers of fishing vessels should ensure that their crew use the correct equipment provided for any task onboard. If the equipment proves impractical bring it to the skipper's/ owner's attention so that something can be done about it.

Designing a fish hold with only one means of access on a vessel of this size must be questioned. While loading or unloading a catch, access in or out of the hold is restricted. To ventilate such a space quickly, or exit it in an emergency, two means of access are necessary, as detailed in the guidance proposed for vessels over 25 metres.

In 2005, the Merchant Shipping and Fishing Vessel (Lifting Operations and Lifting Equipment) Regulations, known as LOLER, will come into force. The regulations will require the lifting gear to be marked with its safe working load and will ban the use of lifting gear to hoist crew members, the consequences of which have been shown in this case.

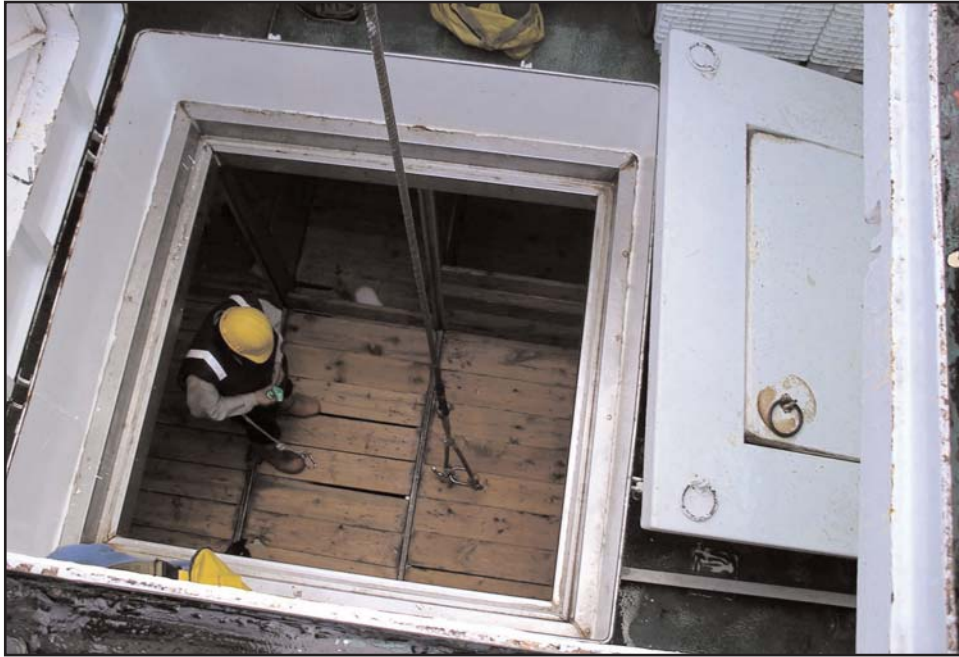
Access to the fish hold was by means of a portable ladder, but the crew rarely used it, as it was heavy and cumbersome and stowed some distance away from the fish hold hatch. Normally, the crew climbed in and out of the hold, but on this occasion, the last two deckhands chose to use the lifting gear. They clipped the fish box lifting hooks together to make a stirrup into which they each placed a foot. They then shouted up to the main deck to hoist. The winchman heard the shouts to lift and began lifting. When the two deckhands were level with the main deck, their feet slipped from the stirrup and they fell back into the fish hold. One of the deckhand's fall was broken on the way down and he was able to get out of the fish hold by himself. The other deckhand fell straight to the bottom of the fish hold and, when the other crew reached him, he was found unconscious. The deckhands were taken to hospital where they were kept for 4 days.

- The skipper had not intervened to stop the unsafe practice of hoisting deckhands out of the hold by the lifting gear.
- The portable ladder, which provided access to the fish hold was heavy and difficult to deploy. It could have been replaced with a lighter one.
- The fish hold hatch was not roped off, which would have prevented anyone from accidentally falling into it.
