MARINE ACCIDENT INVESTIGATION BRANCH

## FLYER TO THE SHIPPING INDUSTRY Entering Dangerous Enclosed/Confined Spaces

Three experienced and qualified seafarers died as a result of entering the anchor chain locker on board a North Sea Emergency Response and Rescue Vessel (ERRV).

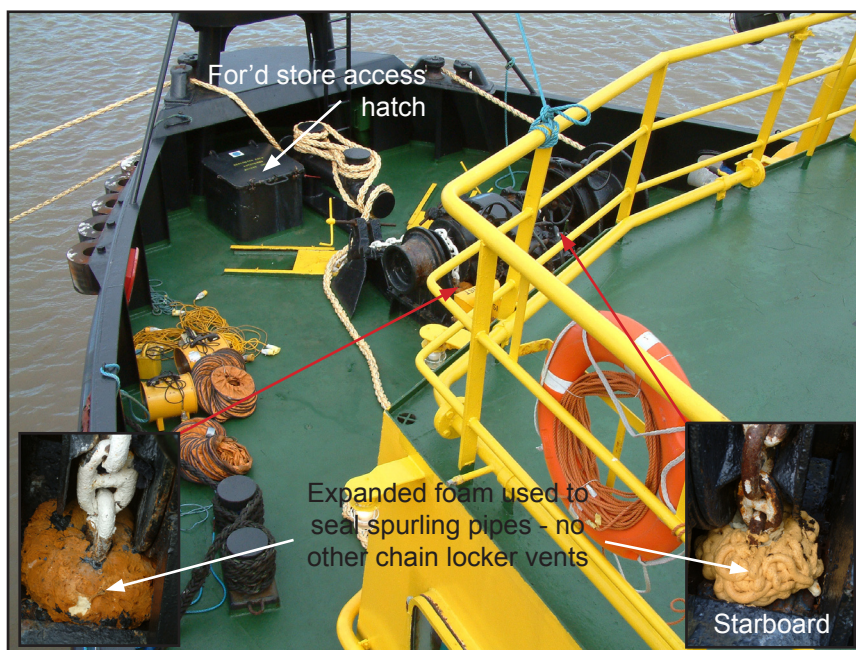
A simple inspection, taking only a few minutes, would have shown that this chain locker was effectively a tank, made air tight by expanding foam used to seal the spurling pipes. Even without the expanding foam this chain locker was a potentially dangerous enclosed/confined space, and a formal safe entry procedure should have been followed.
