Recurring themes in MAIB accident investigations

**Capsize of a Beam trawler in the English Channel.**

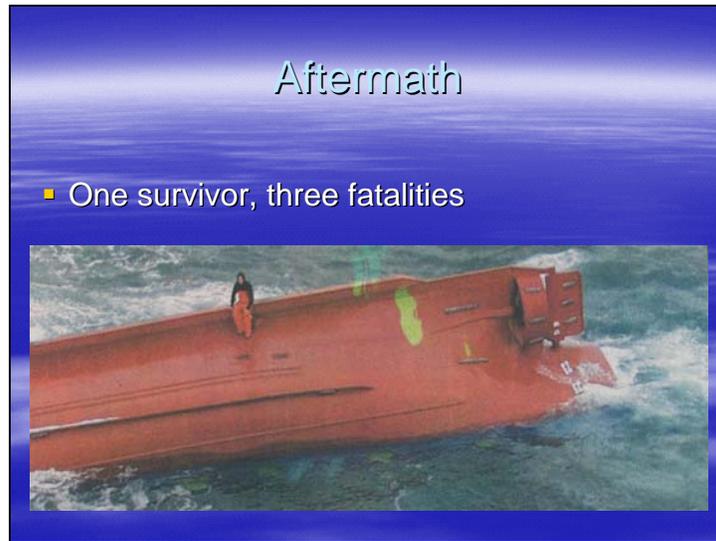
You find yourself in the water and manage to climb on to the upturned hull. You see the bodies of the two deckhands float past but are unable to pull them on board. You hear knocking noises from within the hull and presume they are from the your uncle, the skipper, but there is nothing you can do. You have no way of contacting other vessels and night falls.
