MARINE ACCIDENT INVESTIGATION BRANCH

Bridge Watchkeeping Safety Study

Safety Study 1/2004
July 2004

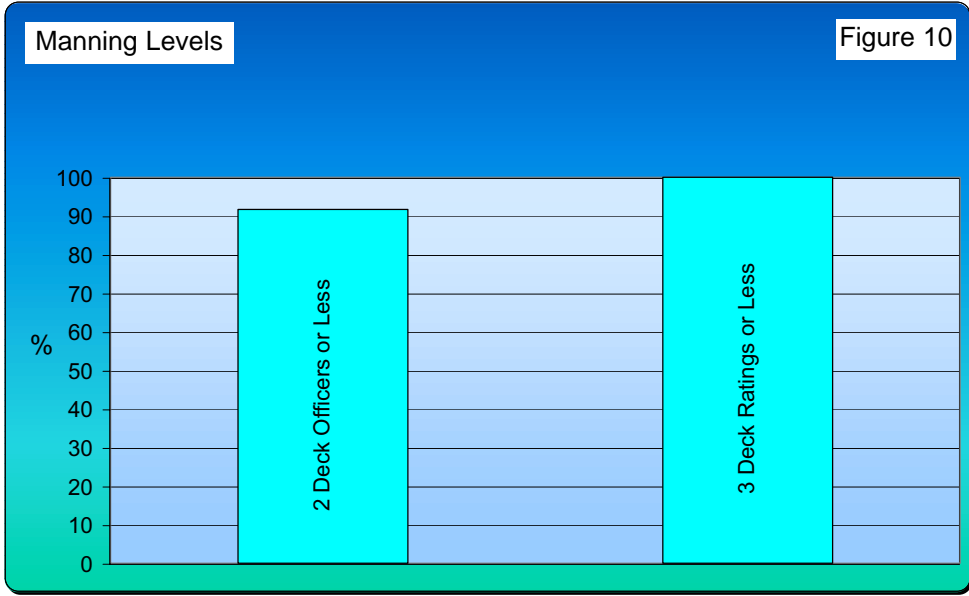
Figure 10

Manning Levels

Figures 9 -11 Groundings - Sole Watchkeeper

Twelve vessels grounded with sole watchkeepers. All were dry cargo/container vessels, 84% were less than 3,000gt (**Figure 9**); 92% carried only two deck officers, and all had three or fewer deck ratings (**Figure 10**). All of these groundings occurred in clear or good visibility, and 75% occurred during darkness. Only one occurred in a port or harbour area, the remainder occurred during coastal passage (**Figure 11**).

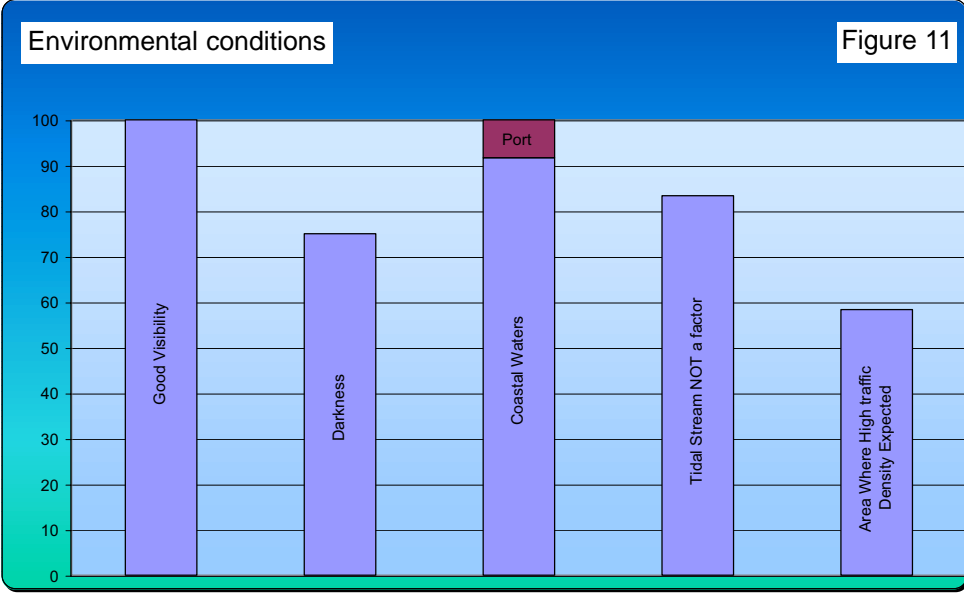
Figure 11

Environmental conditions

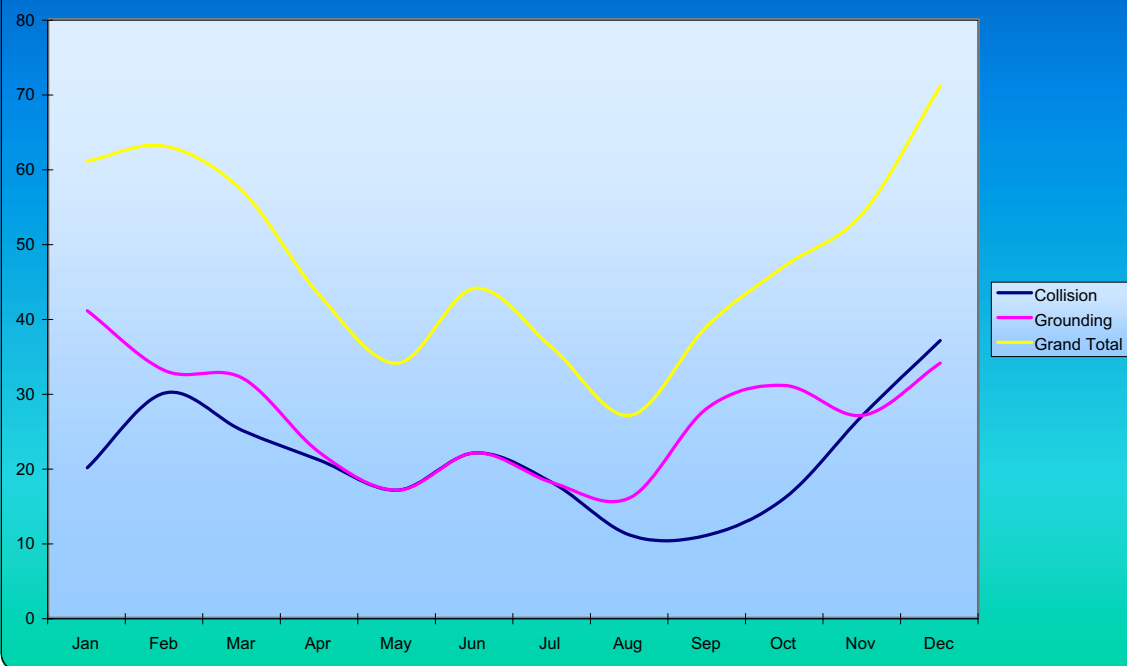
Figure 14

Number of merchant vessels >500gt involved in collisions or groundings in UK waters / month of accident

Even when opportunities to rest arise, there is no guarantee that a bridge watchkeeping officer wants to, or is able to, sleep. Personal tasks such as telephoning or writing home still have to be completed, and the noise and motion of the ship, as well as ambient levels of temperature and light, will all affect an individual's ability to sleep. The fact that many of these factors are influenced by the weather might help explain why the majority of groundings occur in the winter months, when outside temperatures are lower, the incidence of higher sea states is greater, and the nights are longer. A similar seasonal distribution of groundings was found among all vessels over 500gt within UK waters between 1994 and 2003 (**Figure 14**).
